**Flood Control Project Maintenance
Levee Inspections**

2018 Channel Summary Report

DWR Sutter Maintenance Yard

Big Chico Creek

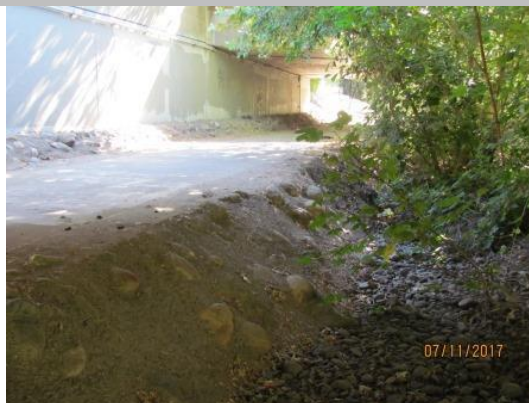
Photo 2 of 2 : CH_2018_NA0060_12_34_20180716_00013.jpg

View of the revetment along the abutment of the bridge on the right bank looking upstream, 2017.

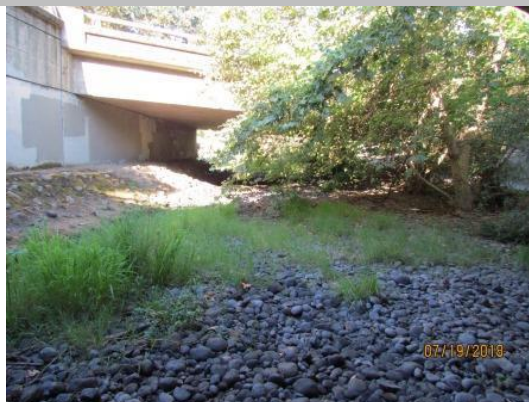
Photo 2 of 2 : CH_2018_NA0060_12_36_20180731_00056.jpg

Rating **	M	Issue No.	36 (cont)	GPS Lat/Long
Issue Type +	Ma	Location *		39.735670 °
Category	Rivers, Channels & Designated Flood			-121.814510 °
Item	Vegetation & Obstructions			
DWR ID	DWR_NA0060_12_c_2012_36			
Action/Comments				
Inspector Comments: There is vegetation in the channel, the flow may be impeded in high water.

View looking downstream from under the bridge, 2018.

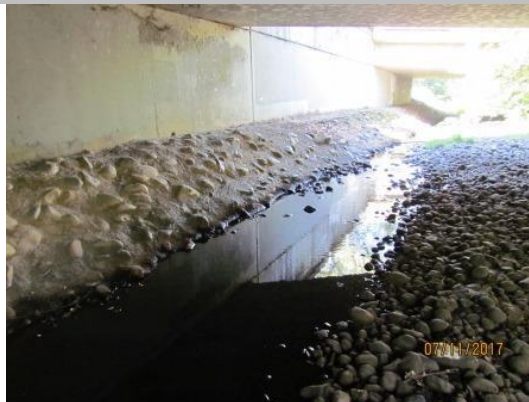
Photo 1 of 2 : CH_2018_NA0060_12_39_20180716_00016.jpg

Inspector Comments: Riprap is visible and appears properly maintained.

View of the revetment along the abutment of the bridge on the left bank looking downstream, 2017.

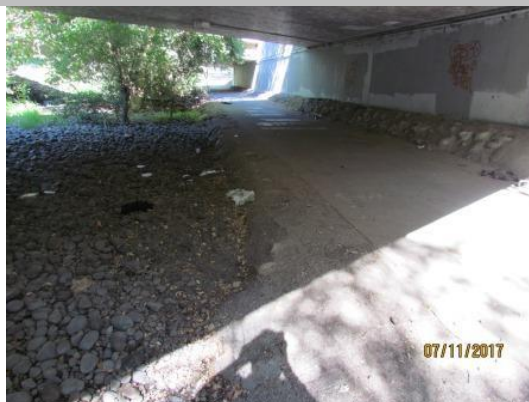
Photo 2 of 2 : CH_2018_NA0060_12_39_20180716_00017.jpg

View of the revetment along the abutment of the bridge on the right bank looking downstream, 2017.

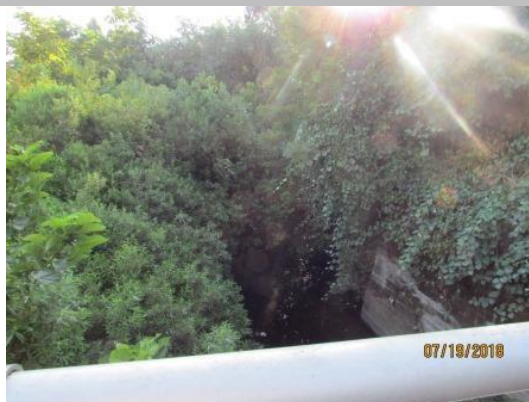
Photo 1 of 1 : CH_2018_NA0060_12_82_20180731_00057.jpg

Rating **	M	Issue No.	82	GPS Lat/Long
Issue Type +	Ma	Location *		39.733204 °
Category	Rivers, Channels & Designated Flood			-121.819610 °
Item	Vegetation & Obstructions			
DWR ID	DWR_NA0060_12_c_2015_82			
Action/Comments				
Inspector Comments: There is vegetation in the channel and it appears to potentially impede the flow.

View of the channel from the bridge facing upstream, 2018.

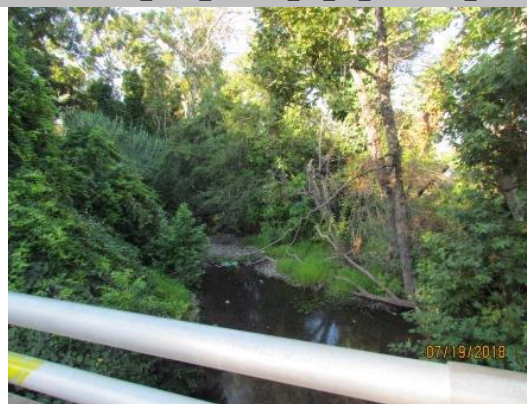
Photo 1 of 1 : CH_2018_NA0060_12_89_20180731_00058.jpg

Inspector Comments: There is some vegetation on the banks, but the channel is clear and the flow does not appear to be impeded.

View of the channel from the bridge facing downstream, 2018.

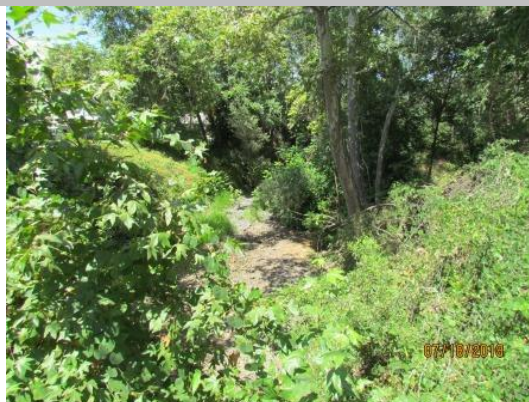
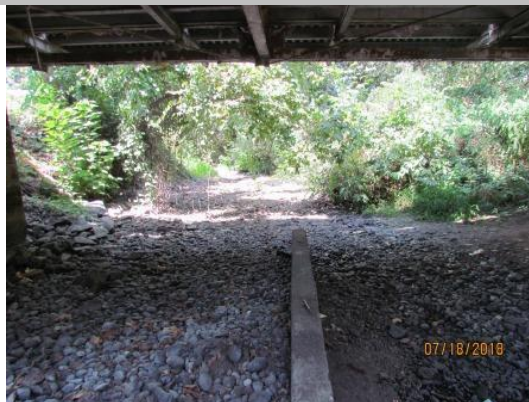
Inspector Comments: There is vegetation in the channel and overhanging the channel, the flow could be impeded.

View of the channel from the bridge facing upstream, 2018.

View of the channel from under the bridge facing upstream, 2018.

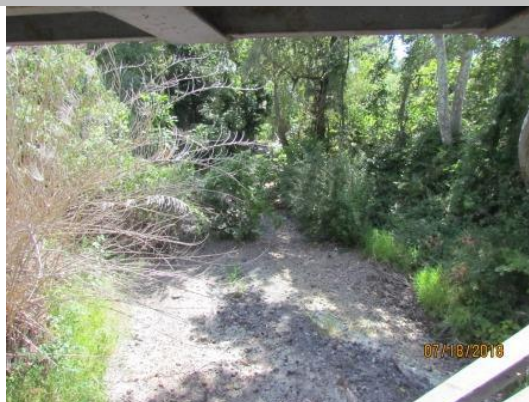
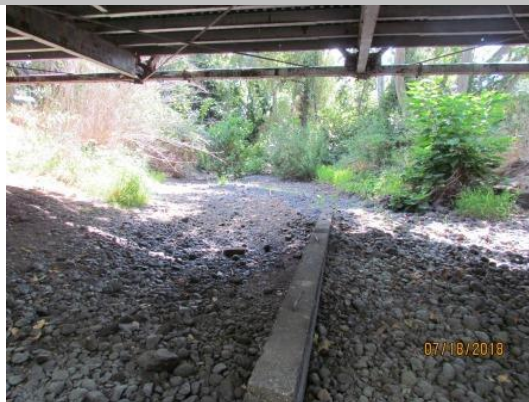
Inspector Comments: There is vegetation in the channel, overhanging the channel, and arundo. The flow does appear slightly impeded.

View of the channel from the bridge facing downstream, 2018.

View of the channel from under the bridge facing downstream, 2018.

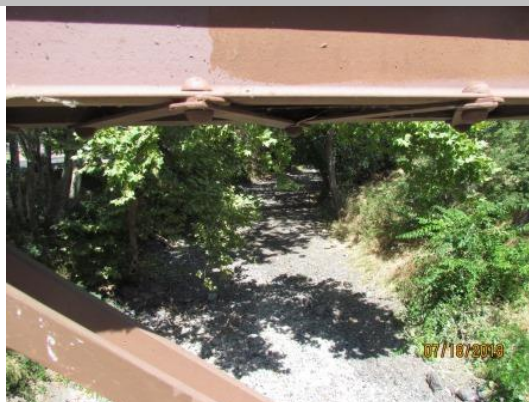
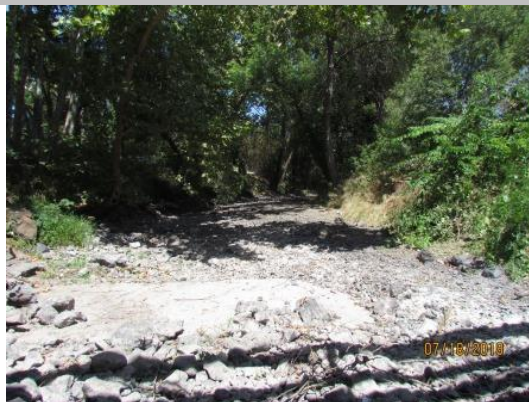
Inspector Comments: There is vegetation in the channel, it does not appear to impeded the flow.

View of the channel from the bridge facing upstream, 2018.

View of the channel from the creek bed facing upstream, 2018.

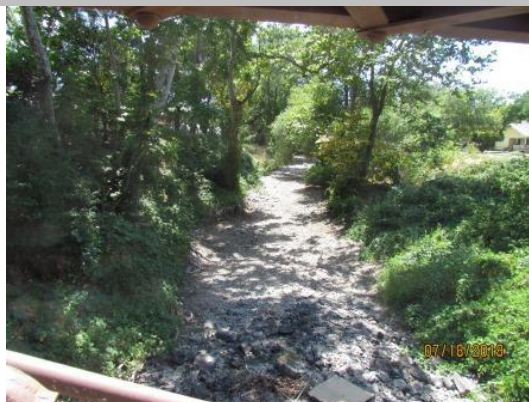
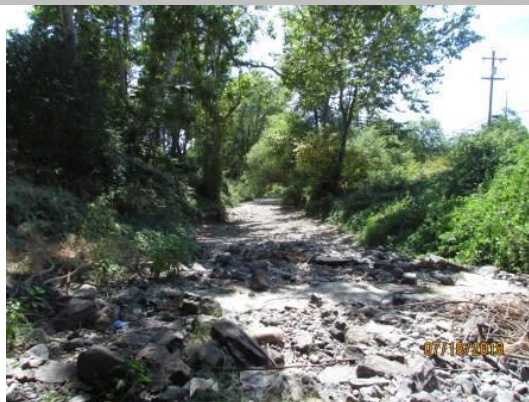
Check Point / View				
Olive St / Down				
Rating **	A	Issue No.	56	GPS Lat/Long
Issue Type +	Ma	Location *		39.726792 °
Category	Rivers, Channels & Designated Flood			-121.829713 °
Item	Vegetation & Obstructions			
DWR ID	DWR_NA0060_12_c_2012_56			
Action/Comments				
Inspector Comments: There is vegetation in the channel, the flow does not appear impeded.

View of the channel from the bridge facing downstream, 2018.

View of the channel from under the bridge facing downstream, 2018.

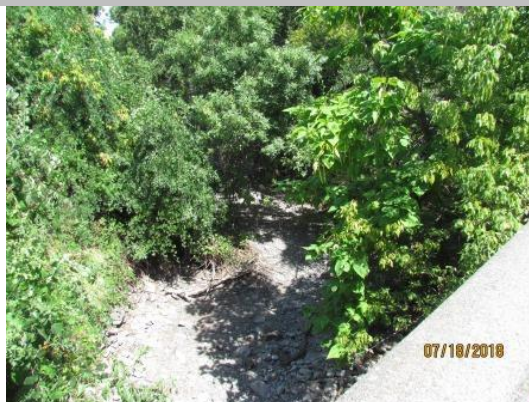
Photo 1 of 1 : CH_2018_NA0060_12_61_20180801_00074.jpg

Inspector Comments: Scattered obstructions and vegetation, and may impede the flow of the channel.

View of the channel from the bridge facing upstream, 2018.

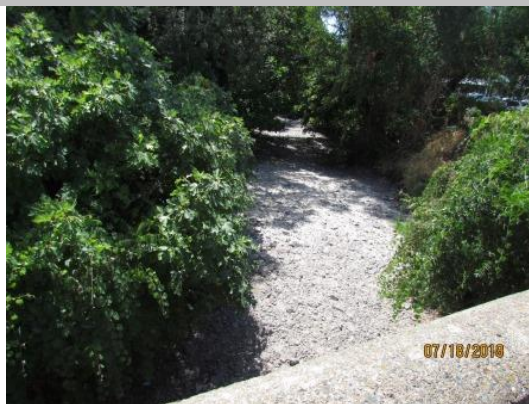
Photo 1 of 1 : CH_2018_NA0060_12_66_20180801_00073.jpg

Rating **	A	Issue No.	66	GPS Lat/Long
Issue Type +	Ma	Location *		39.724328 °
Category	Rivers, Channels & Designated Flood			-121.835233 °
Item	Vegetation & Obstructions			
DWR ID	DWR_NA0060_12_c_2012_66			
Action/Comments				
Inspector Comments: There is vegetation in the channel, the flow does not appear impeded.

View of the channel from the bridge facing downstream, 2018.

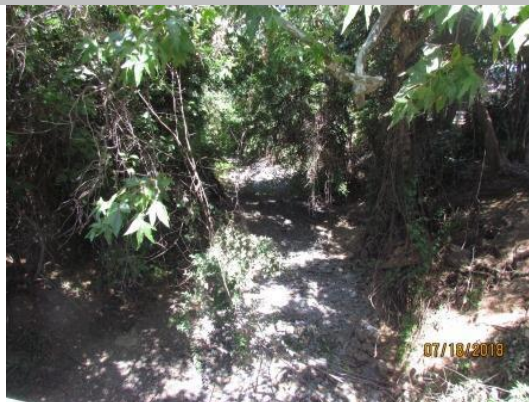
Photo 1 of 1 : CH_2018_NA0060_12_94_20180801_00075.jpg

Inspector Comments: Scattered obstructions and vegetation, should not impede the flow of the channel.

View of the channel from the bridge facing upstream, 2018.

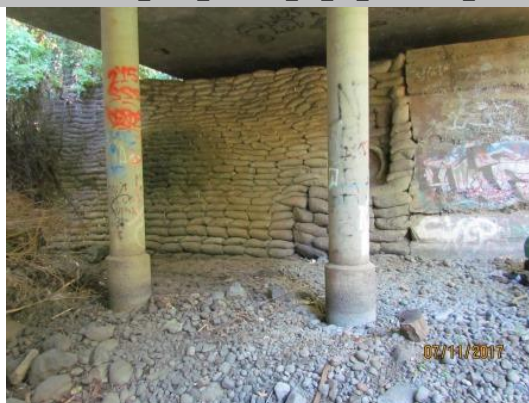
Photo 1 of 1 : CH_2018_NA0060_12_97_20180716_00038.jpg

Rating **	A	Issue No.	97	GPS Lat/Long
Issue Type +	Ma	Location *		39.720476 °
Category	Rivers, Channels & Designated Flood			-121.838990 °
Item	Revetments			
DWR ID	DWR_NA0060_12_c_2015_97			
Action/Comments				
Inspector Comments: Sandbag revetment on right bank of abutment, 2017.

View of sandbag revetment on right bank of abutment, 2017.

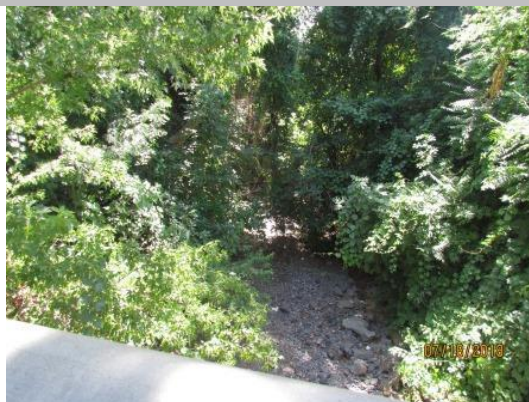
Photo 1 of 1 : CH_2018_NA0060_12_99_20180801_00076.jpg

Check Point / View				
Ivy Street / Down				
Rating **	M	Issue No.	99	GPS Lat/Long
Issue Type +	Ma	Location *		39.720476 °
Category	Rivers, Channels & Designated Flood			-121.838990 °
Item	Vegetation & Obstructions			
DWR ID	DWR_NA0060_12_c_2015_99			
Action/Comments				
Inspector Comments: Scattered obstructions and vegetation, may impede the flow of the channel.

View of the channel from the bridge facing downstream, 2018.

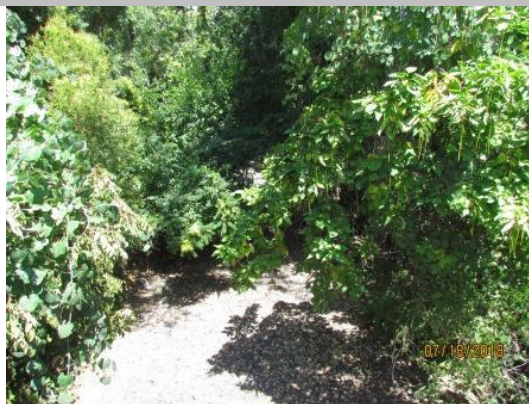
Photo 1 of 1 : CH_2018_NA0060_12_104_20180801_00077.jpg

Rating **	A	Issue No.	104	GPS Lat/Long
Issue Type +	Ma	Location *		39.718434 °
Category	Rivers, Channels & Designated Flood			-121.843512 °
Item	Vegetation & Obstructions			
DWR ID	DWR_NA0060_12_c_2015_104			
Action/Comments				
Inspector Comments: The channel appeared to be free of any vegetation that would impede the flow.

View of the channel from the bridge facing upstream, 2018.

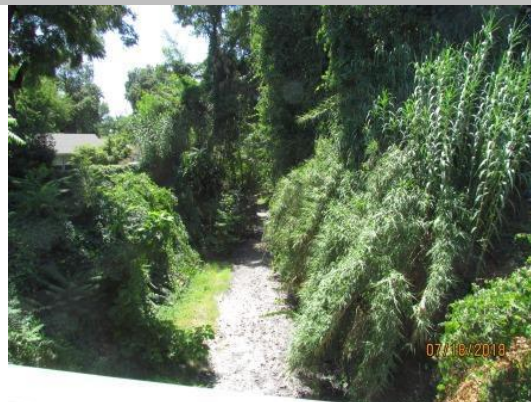
Photo 1 of 1 : CH_2018_NA0060_12_109_20180801_00078.jpg

Check Point / View				
Walnut Street / Down				
Rating **	A	Issue No.	109	GPS Lat/Long
Issue Type +	Ma	Location *		39.718434 °
Category	Rivers, Channels & Designated Flood			-121.843512 °
Item	Vegetation & Obstructions			
DWR ID	DWR_NA0060_12_c_2015_109			
Action/Comments				
Inspector Comments: The channel appeared free of any vegetation that would impede the flow. Although the Arundo should be removed before it chokes down the channel.

View of the channel from the bridge facing upstream, 2018.

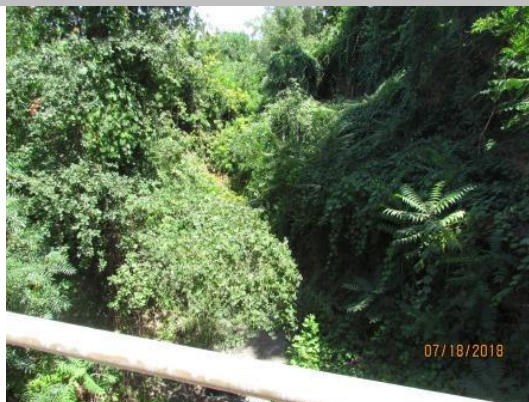
Photo 1 of 1 : CH_2018_NA0060_12_71_20180801_00080.jpg

Check Point / View				
Lone Pine Avenue / Up				
Rating **	M	Issue No.	71	GPS Lat/Long
Issue Type +	Ma	Location *		39.703260°
Category	Rivers, Channels & Designated Flood			-121.868470°
Item	Vegetation & Obstructions			
DWR ID	DWR_NA0060_12_c_2012_71			
Action/Comments				
Inspector Comments: Scattered obstructions and vegetation, and may impede the flow of the channel.

View of the channel from the bridge facing upstream, 2018.

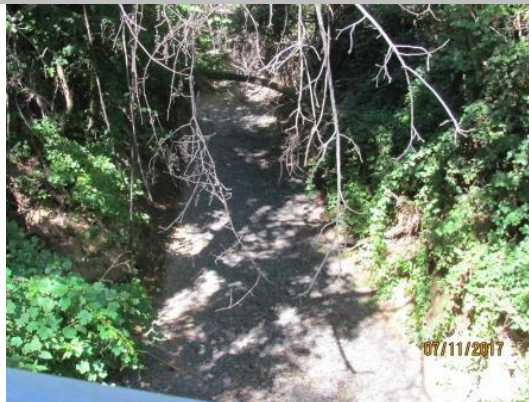
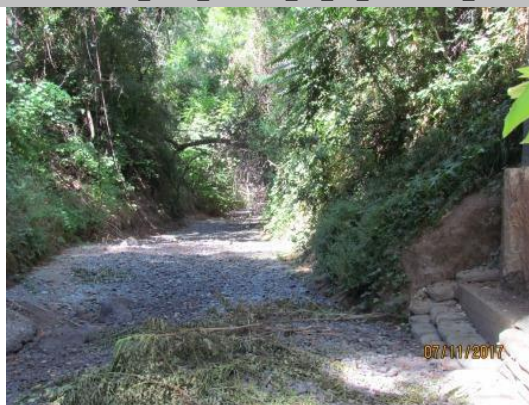
Inspector Comments: There is vegetation in the channel, the flow does not appear impeded.

View of the channel facing downstream from bridge, 2017..

View of the channel under the bridge facing downstream, 2017.
